Property Inspection Report

Sample Report - RESELL
Address, City, TX
Zip Code
Subdivision
Key Map 123A

Thursday, October 29, 2009

Clay M. Collins
Professional Inspector, TREC License #7147
Grace Home Inspection Services, LLC
Telephone 281 489-9040 Cell 713 503-1820
Web page: www.gracehis.com e-mail: clay@gracehis.com

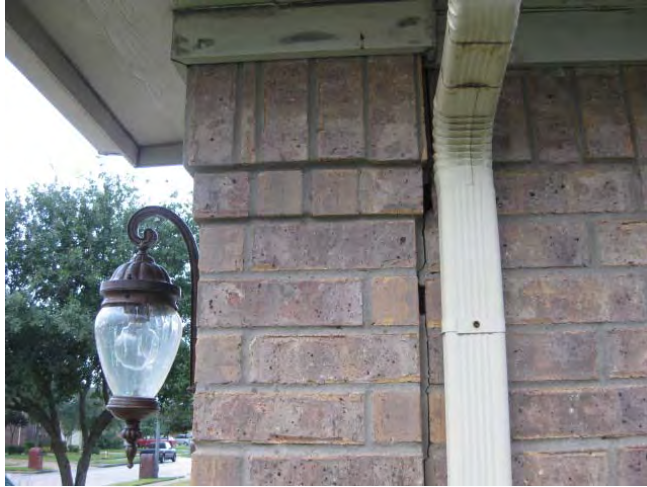
§ I. Structural Systems A. Foundations

- mortar cracks up to 1/8" wide at the top of the right front corner
- cracks in the gypsum ceiling cover of the master bedroom (see § I. Structural Systems F. Ceilings and Floors for additional comments)

These are not, in this inspector's opinion, structurally significant or in immediate need of repair. The areas, however, should be monitored for additional movement.

There is a separation of up to 1/8" in the top portion of the mortar joint at the right front corner.

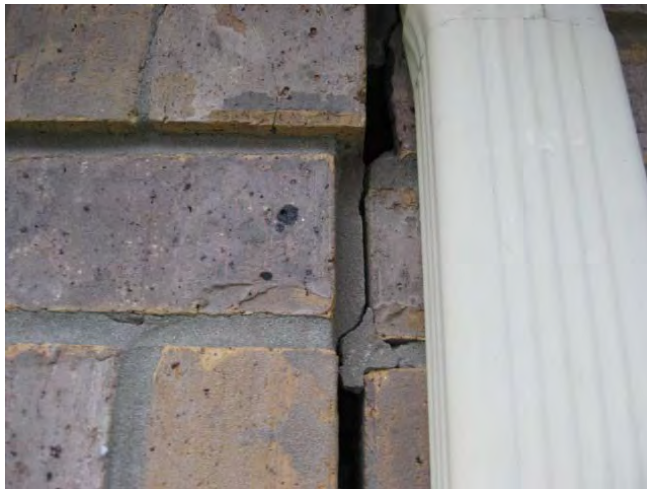
§ I. Structural Systems A. Foundations

There is a separation of up to 1/8" in the top portion of the mortar joint at the right front corner.

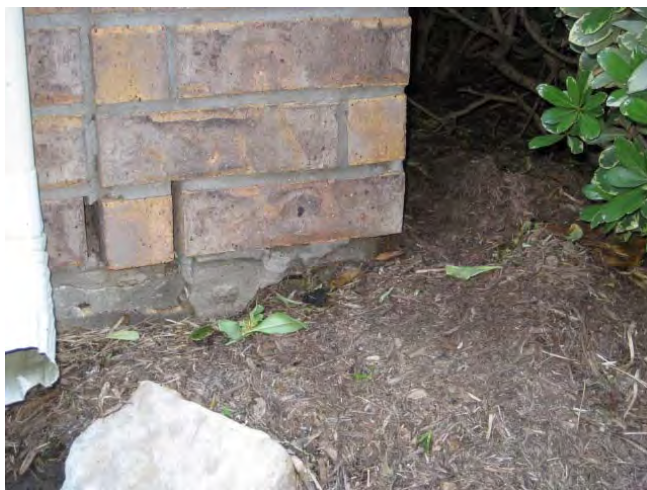
§ I. Structural Systems A. Foundations

🔍 Maintenance tip: Spalling found within 12" of the foundation's corners may occur because of bonds between the brick and brick ledge and differential thermal movement. Spalling was noted at self-evident corners. While not in immediate need of repair, we *recommend* caulking any separations which have some portion beneath grade to minimize the risk of WDI infestation. Should, at some point in time, the corner fully detach, repair would be called for to ensure that the overlying brick veneer continues to be supported.

Common spalling was noted at self-evident corners.

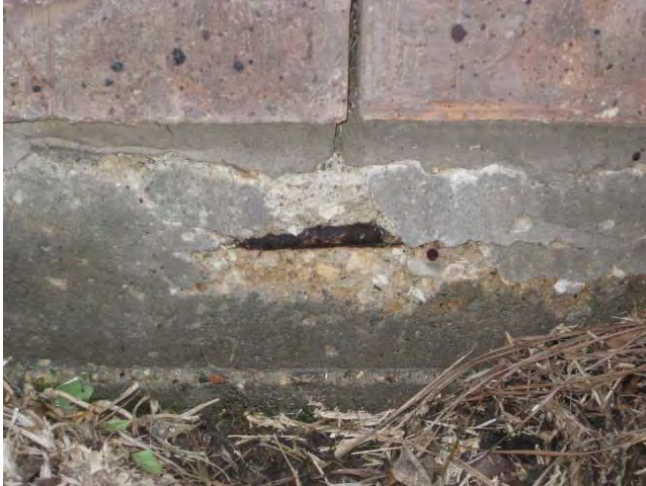
§ I. Structural Systems A. Foundations

🔍 Re-bar is exposed at the foundation grade beam. This foundation is strengthened with static (not under tension) steel reinforcing bars (rebar). This exposure is typically caused by chemical reaction of compounds within the concrete to the steel. As a result, the steel corrodes and expands which, in turn, causes spalling (the concrete flakes off). The exposed cables should be sealed to minimize corrosion.

There is exposed reinforcing steel bar (i.e. re-bar) at the left front corner.

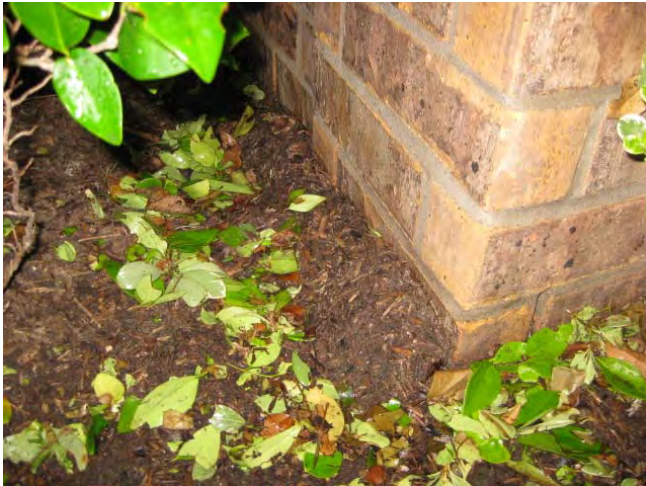
§ I. Structural Systems B. Grading and Drainage

■ The soil levels are high against the exterior beam at the foundation grade beam. When soil levels and vegetation are high against the face of the foundation it promotes water penetration, wood rot and insect infestation. Brick veneer wall cladding should have about 4" of clearance between the soil and the first course of bricks, and other materials should have 6" of clearance between the wood and the soil. We recommend lowering the grade and removing vegetation in these areas.

High ground cover (i.e. soil, mulch or rock) was noted at the foundation grade beam within the garden beds.

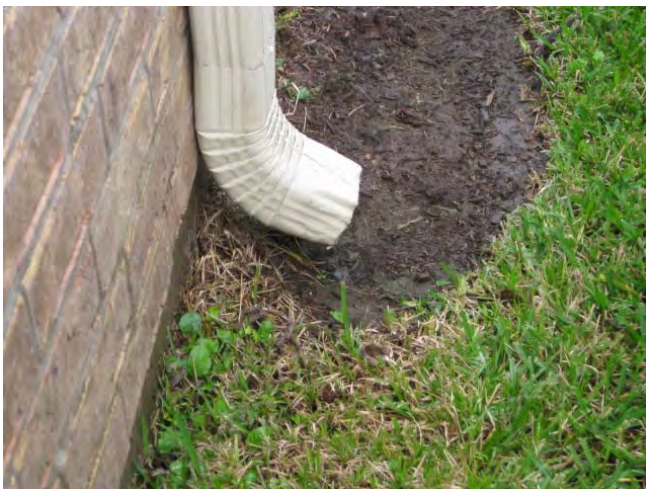
§ I. Structural Systems B. Grading and Drainage

■ There are downspouts in the gutter system which direct water to the foundation grade beam. This may cause erosion at the foundation and allow undesirable movement. All downspouts should direct water at least 5' away from the foundation.

Gutter system downspouts direct water to the foundation.

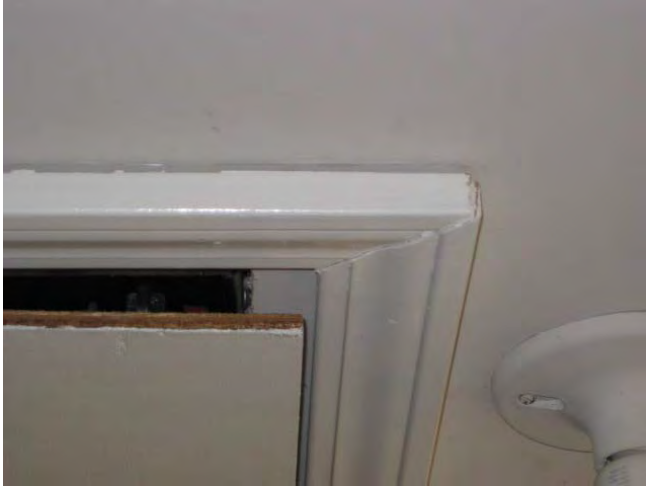
§ I. Structural Systems D. Roof Structure & Attic

The attic stairway within the garage is not tight against the ceiling cover when in a closed position.

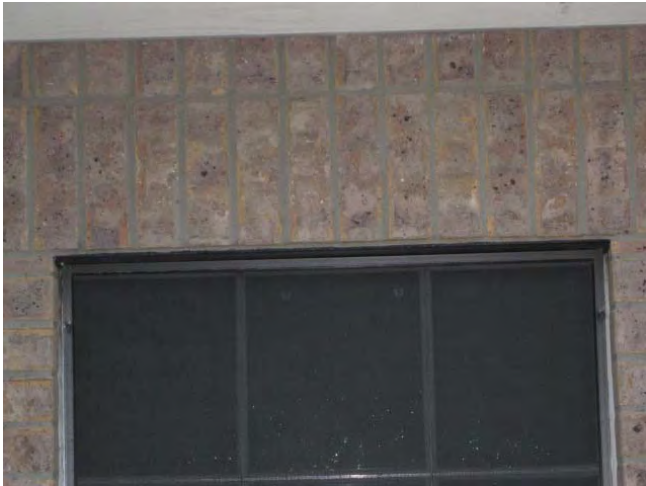
§ I. Structural Systems E. Walls (Interior and Exterior)

There are no weep holes above some steel lintels at windows and doors.

Maintenance tip: Steel lintels above windows and doors should be kept free of corrosion to preserve their useful life.

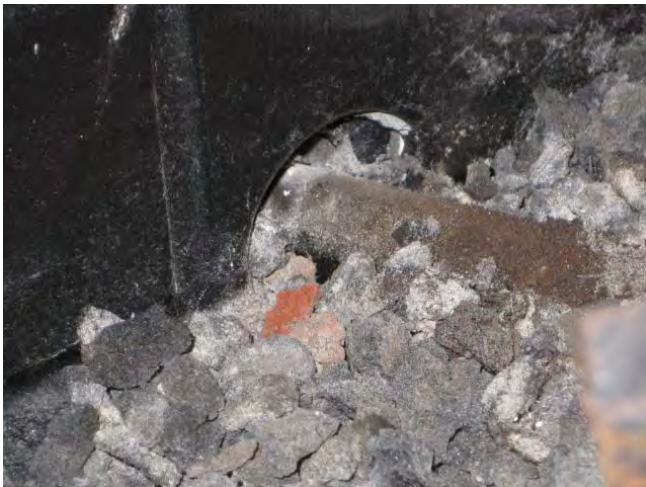
§ I. Structural Systems J. Fireplace and Chimney

The refractory is not sealed at the gas line penetration. The manufacturer's installation instructions should be followed but these openings are generally sealed with insulation, high-temp caulk or medium duty refractory mortar to prevent heated gases from entering into the wood framed wall. We recommend sealing this area for fire and personal safety. See the Addendum for an illustration.

The space between the gas line and the refractory should be sealed.

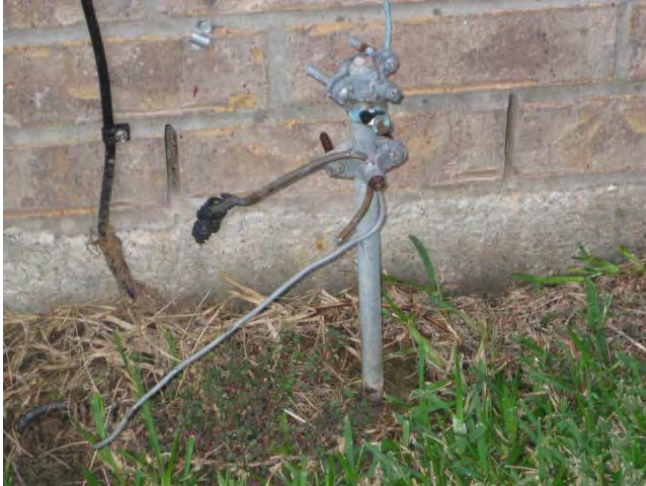
§ II. Electrical Systems A. Service Entrance

The clamp at the ground rod does not appear to be proper (i.e. rated for direct burial). We recommend the use of an "acorn" style clamp, rated for direct burial, on the ground rod for a more secure, longer lasting connection.

The ground rod should be driven fully into the ground.

The ground clamp should be an "acorn" style for durability and direct burial.

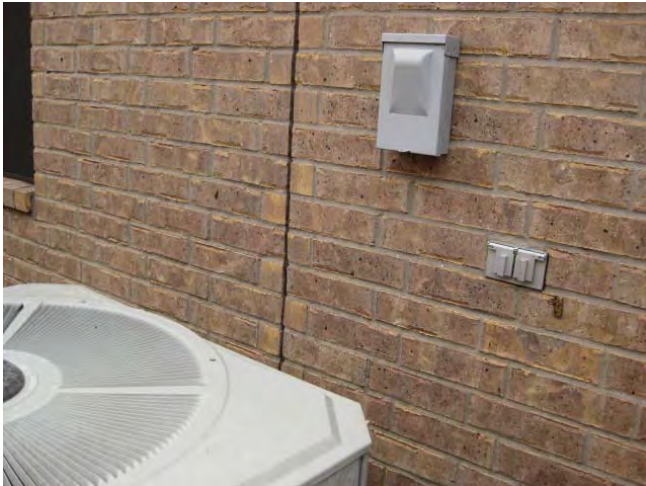
§ II. Electrical Systems B. Branch Circuits

The A/C service disconnect is located behind the condenser and does not have full clearance required for safe access.

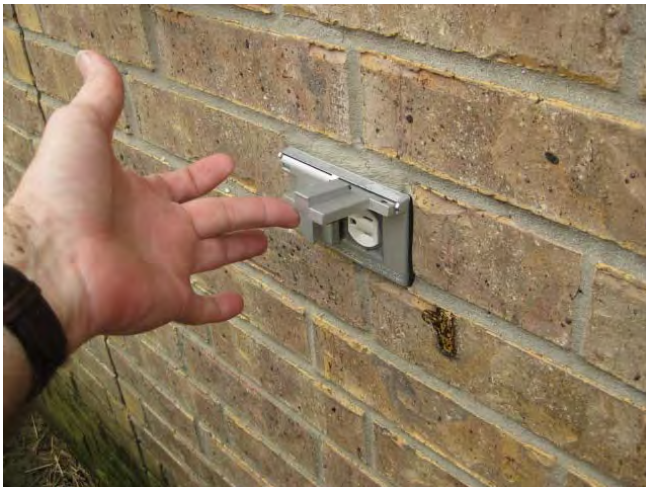
§ II. Electrical Systems B. Branch Circuits

There are improper outlet covers installed out-of-doors. In wet locations, outlets should be equipped to prevent moisture from entering or accumulating within the box. Where installed in a wet location, receptacles should, by today's standards, have an enclosure that is weatherproof whether or not the attachment plug cap is inserted. See the Addendum for an example of such covers recommended for outdoor outlets.

Outlet covers in wet areas should be wet area, or in-use, type covers.

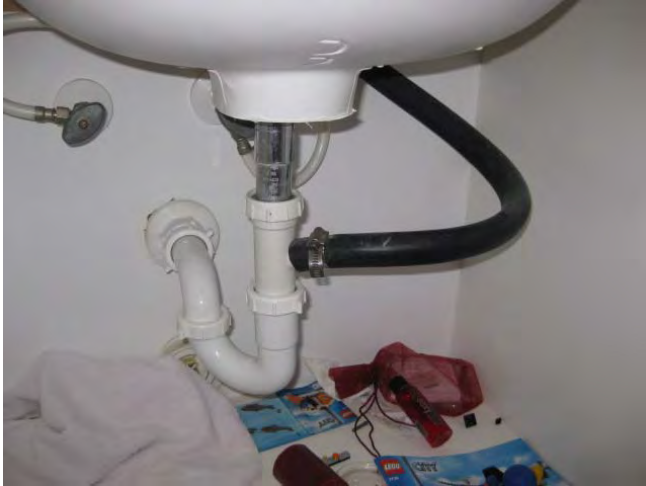
§ III. HVAC Systems B. Cooling Equipment

Maintenance tip: The HVAC system's primary condensate drain line terminates beneath the guest bathroom sink.

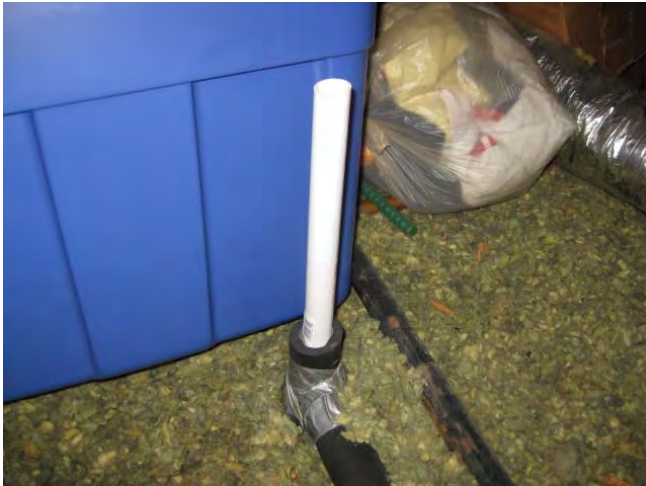
§ III. HVAC Systems B. Cooling Equipment

Maintenance tip: The PVC vent pictured, located at the equipment within the attic space, may be used to clean and/or clear the primary condensate drain line.

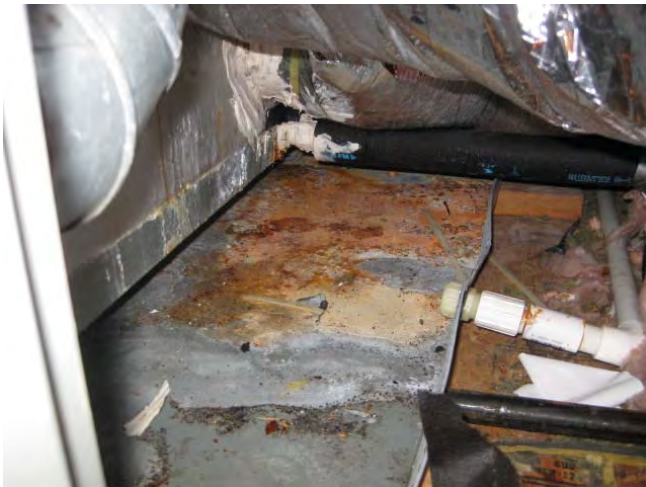
§ III. HVAC Systems B. Cooling Equipment

There is evidence of previous condensate discharge to the safety pan.

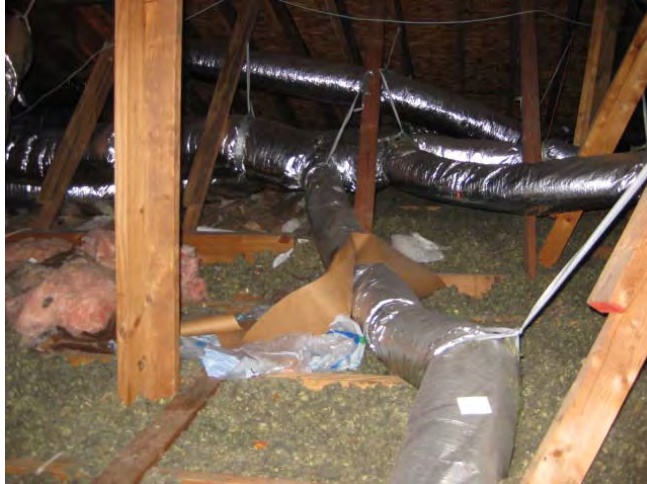
§ III. HVAC Systems C. Ducts and Vents

☑ Portions of the duct within the attic space do not appear properly supported. Air ducts are to be supported at least every 4' by strapping at least 1 ½" wide. This is to prevent constrictions to the airway, prevent deterioration of the duct and insulation, and prevent condensation where the duct might otherwise reset upon insulation or structural members.

Portions of the HVAC duct are not properly supported every 4' with 1 ½" wide strapping.

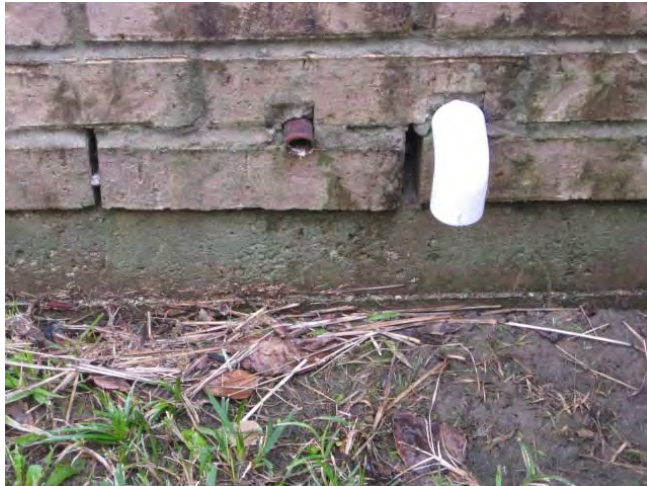
§ IV. Plumbing System C. Water Heating Equipment

The discharge line from the water heater's safety relief valve should be directed downward at its point of termination for personal safety.

Maintenance and safety tip: Should water discharge from the water heater's safety relief valve drain (smaller diameter line) or the safety pan be observed, immediate action should be taken for personal and property safety.

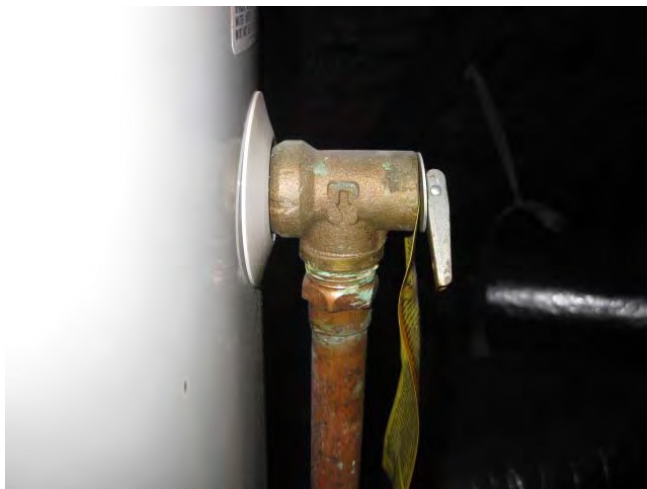
§ IV. Plumbing System C. Water Heating Equipment

Maintenance and safety tip: Should water discharge from the water heater's safety relief valve drain be observed, immediate action should be taken for personal and property safety.

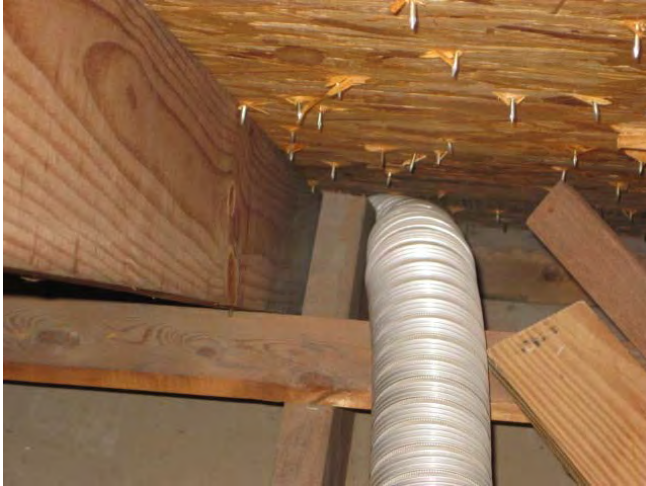
§ V. Appliances G. Bathroom Exhaust Fans and/or Heaters

The bathroom and laundry exhaust fans discharge to the soffit within the attic space.

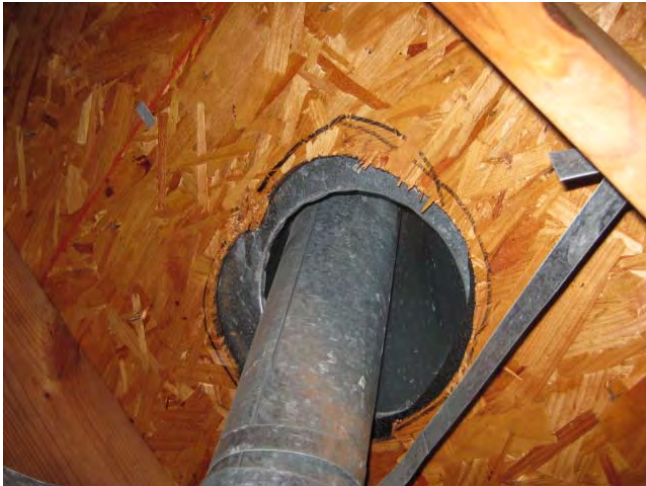
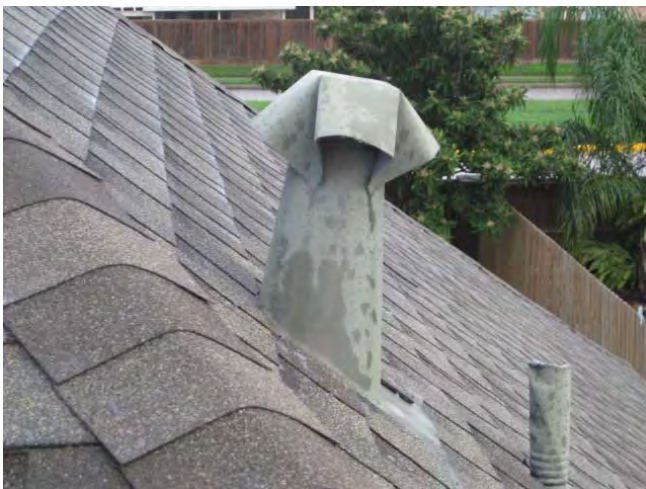
§ V. Appliances K. Dryer Vents

The dryer vent terminates within a roof jack in the attic space and does not appear to incorporate a backdraft damper.
